Wind Mitigation Report

LOCATED AT:
106-01 - 106-09 Southard st
Key West, Florida 33040

PREPARED EXCLUSIVELY FOR:
Shipyard Condominium Building # 6

INSPECTED ON:
Friday, August 29, 2025

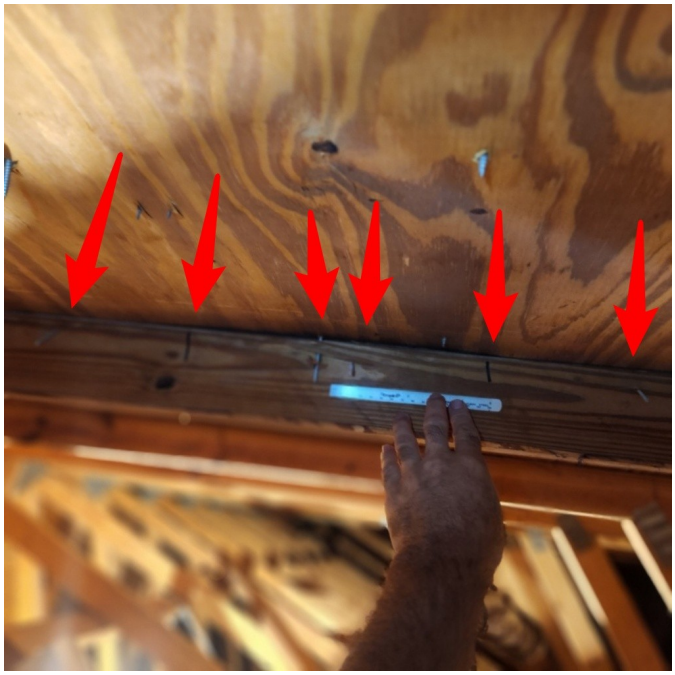
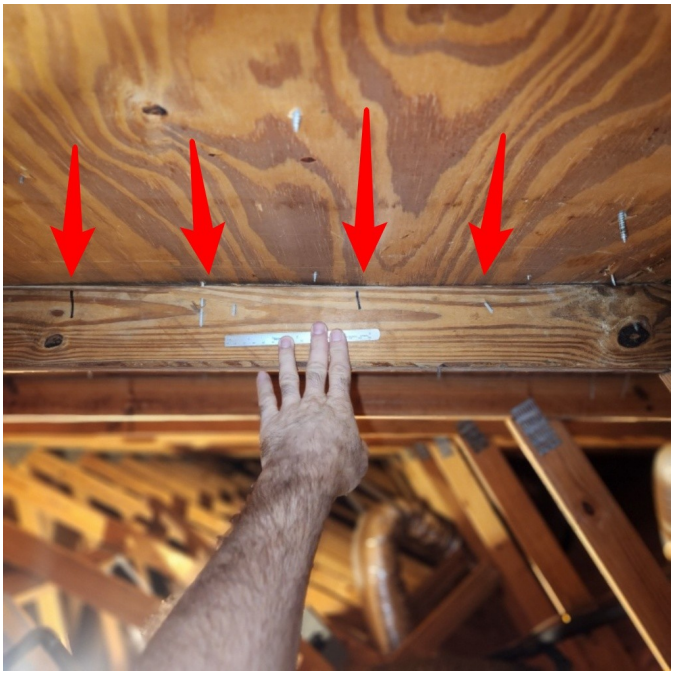
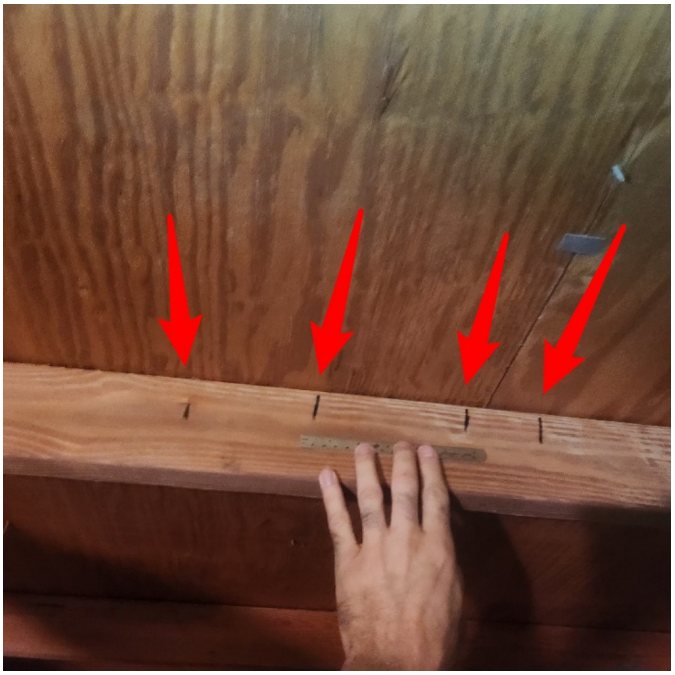
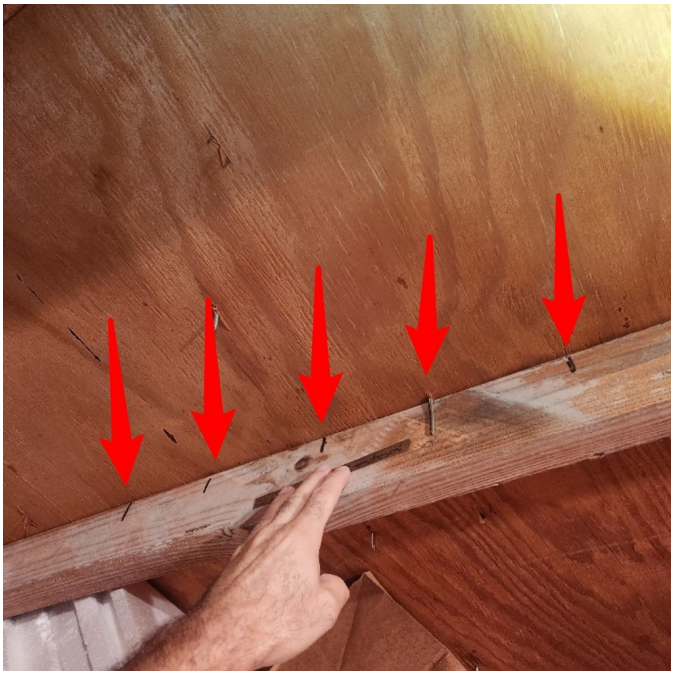
ROOF DECK

5/8 plywood nailed with 8D nails every 6 inches

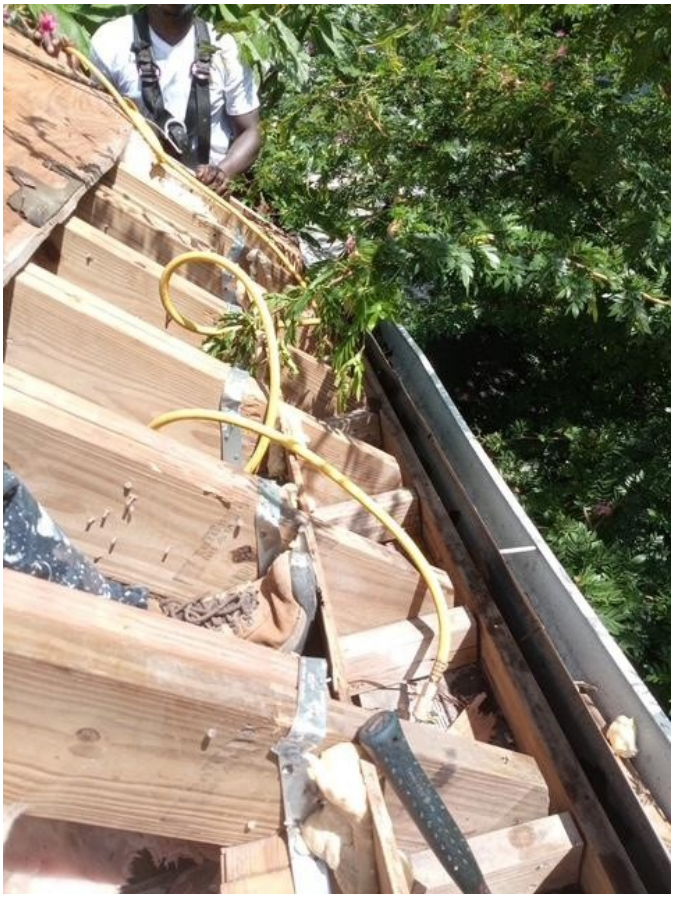
ROOF TO WALL

Double wraps consisting of a one strap nails with 5+ nails on either side .

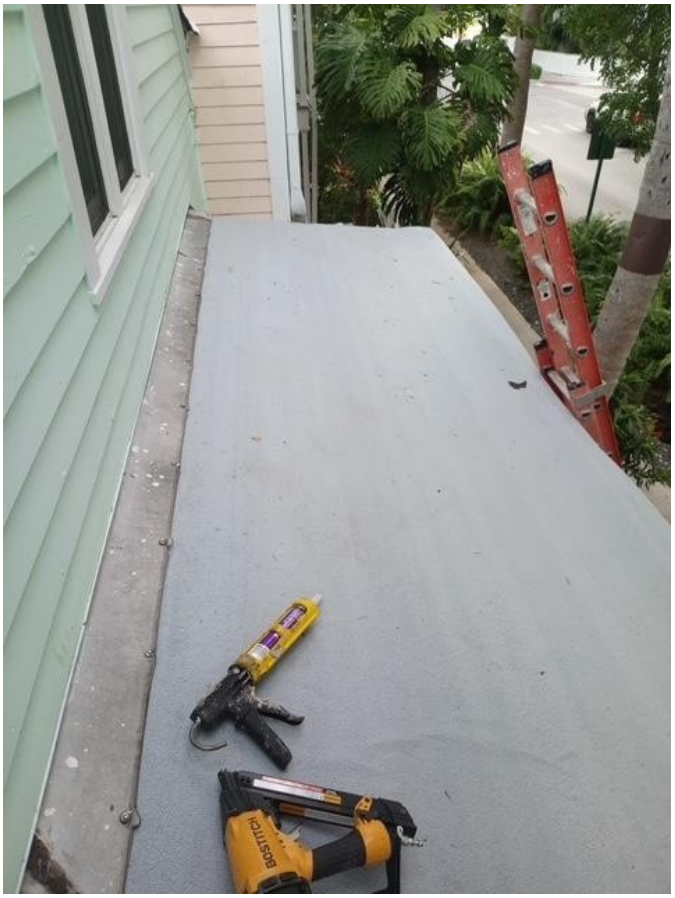
SWR installed

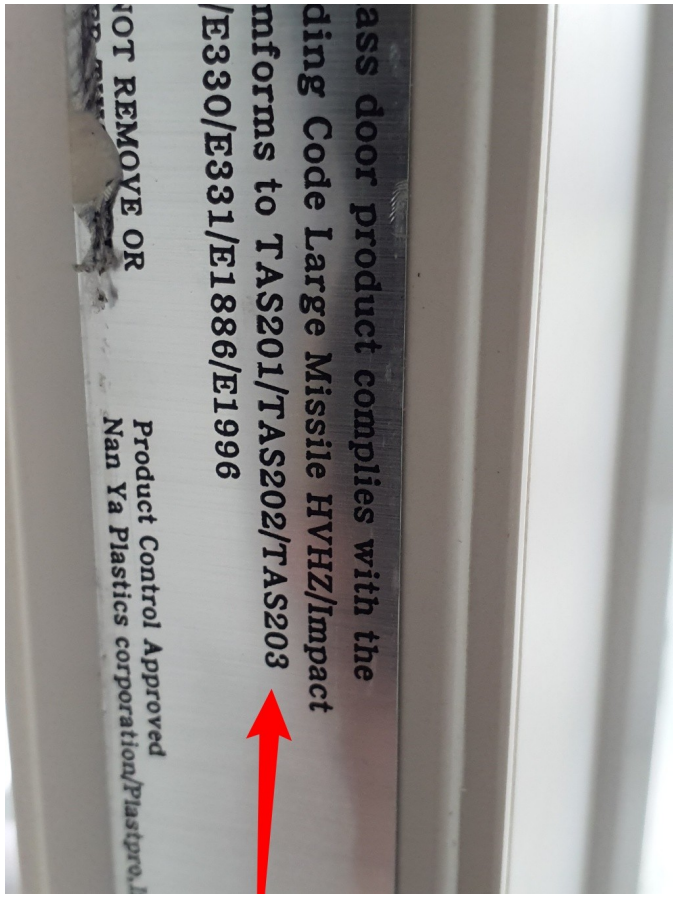
All of the doors are hurricane impact rated

TAS 201 202 203

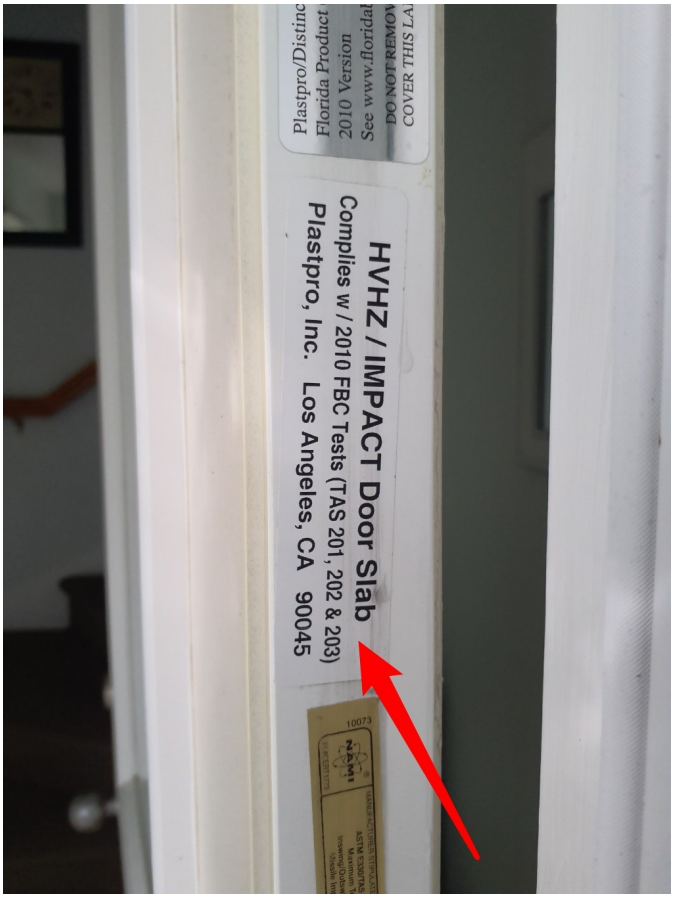
Miami Dade county approved

TAS 201 202 203

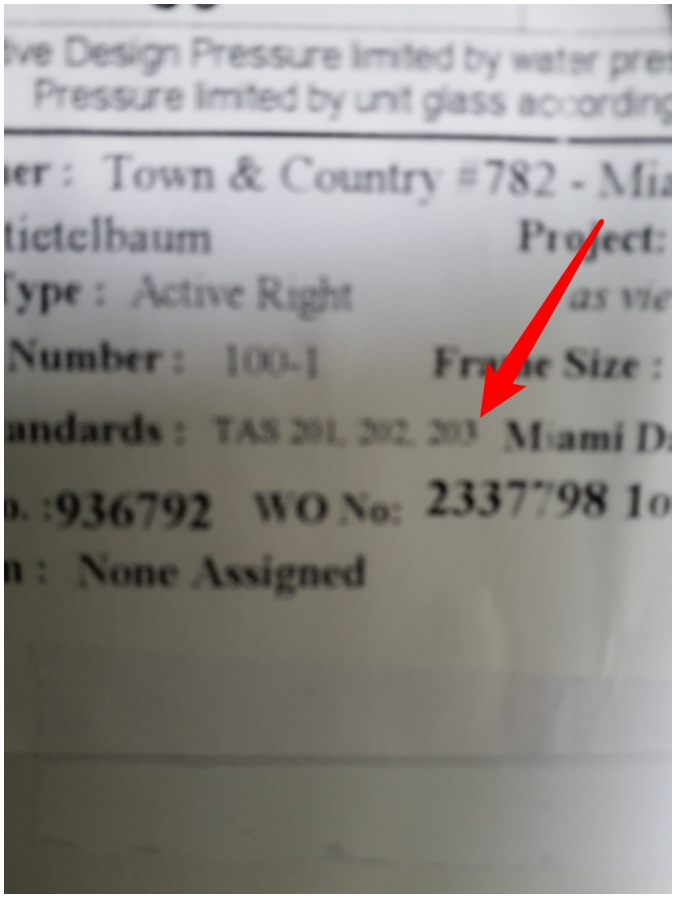
TAS 201 202 203

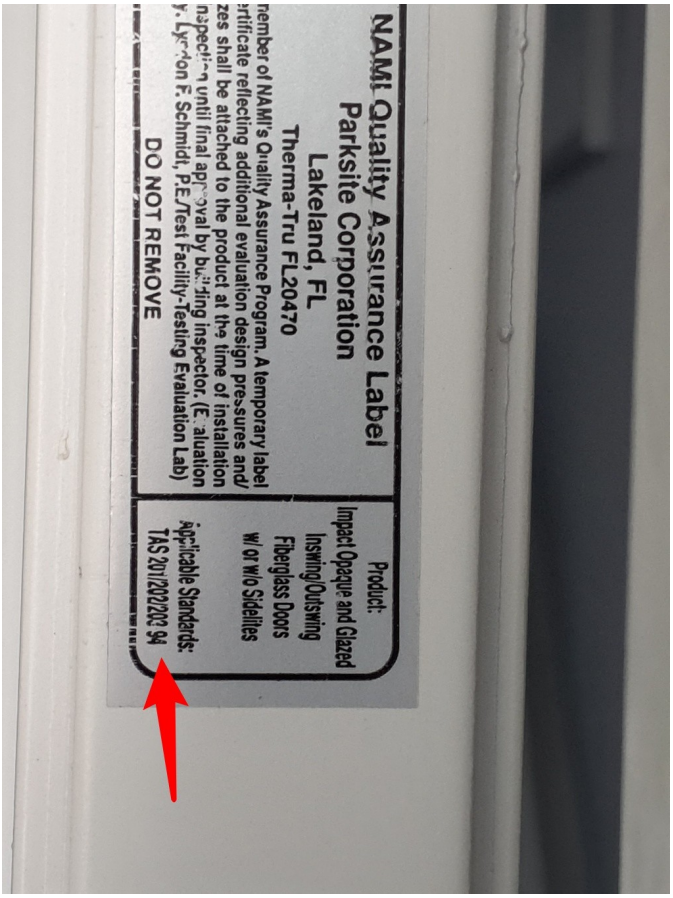
TAS 201 202 203

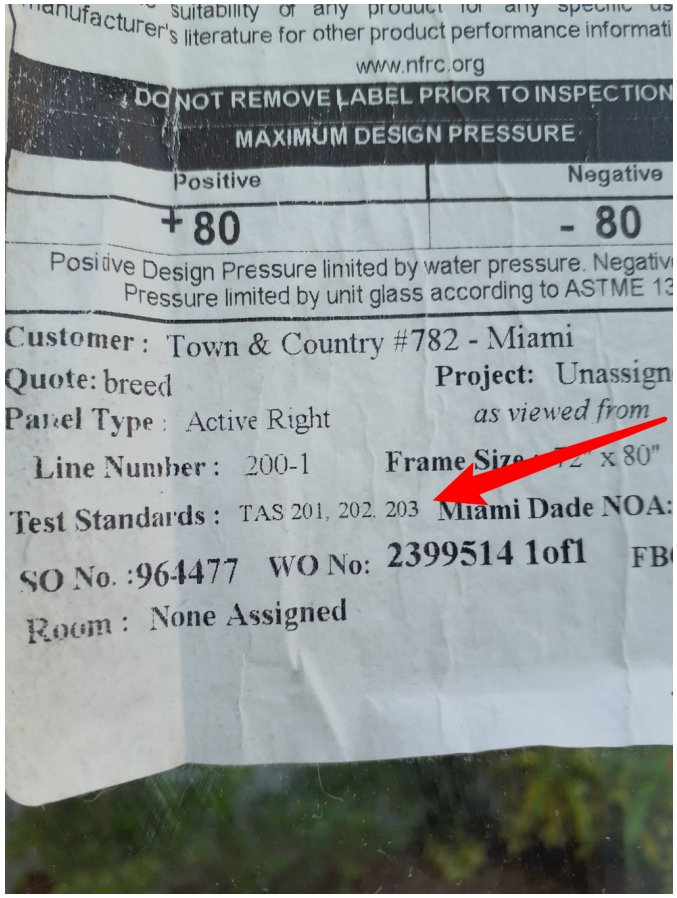
TAS 201 202 203

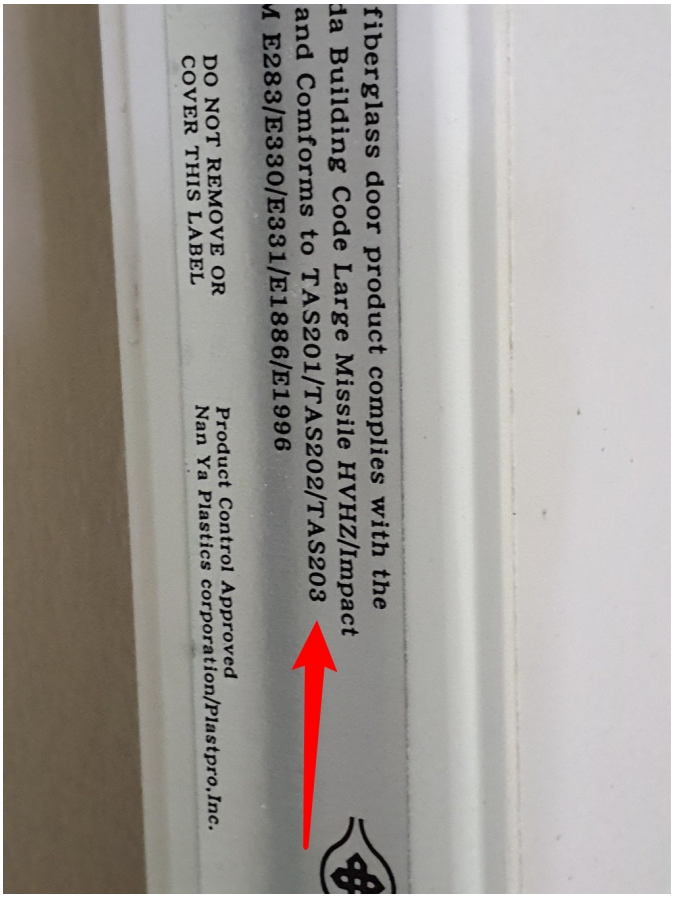
TAS 201 202 203

Miami Dade county approved

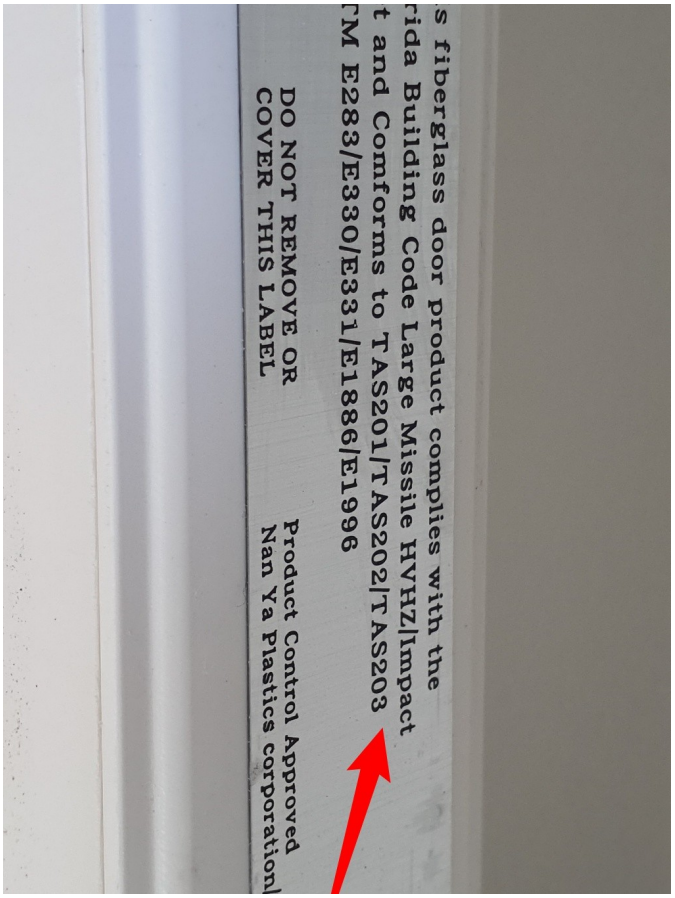
TAS 201 202 203

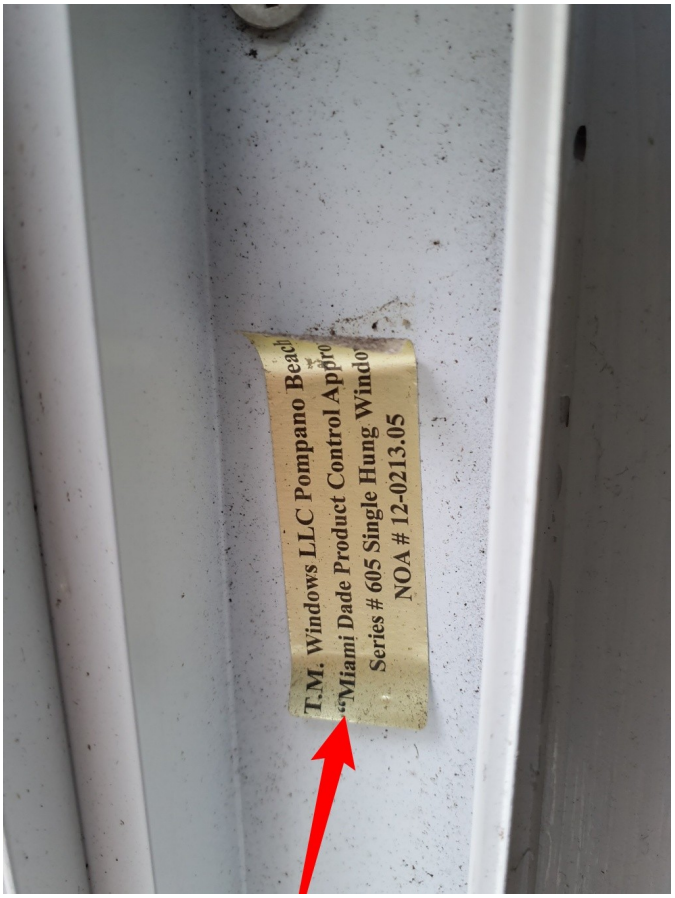
All of the windows are hurricane impact rated

Miami Dade county approved

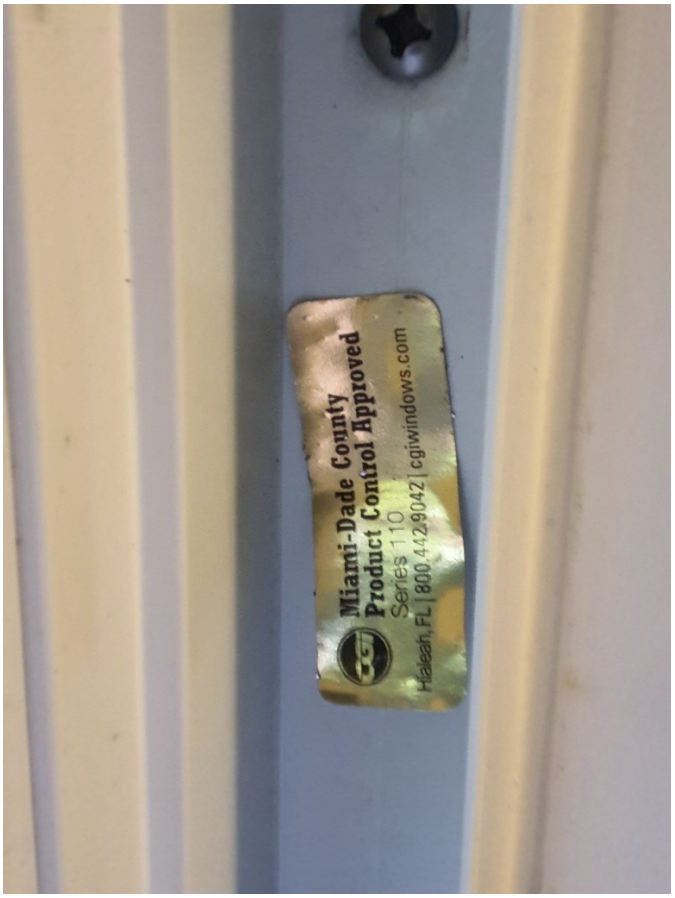
Miami Dade county approved

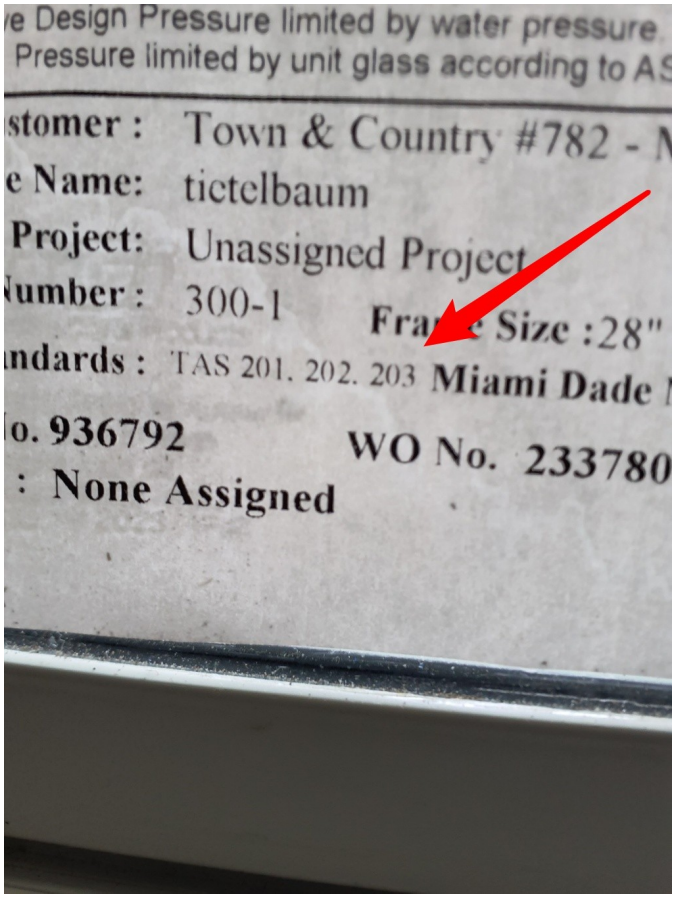
TAS 201 202 203

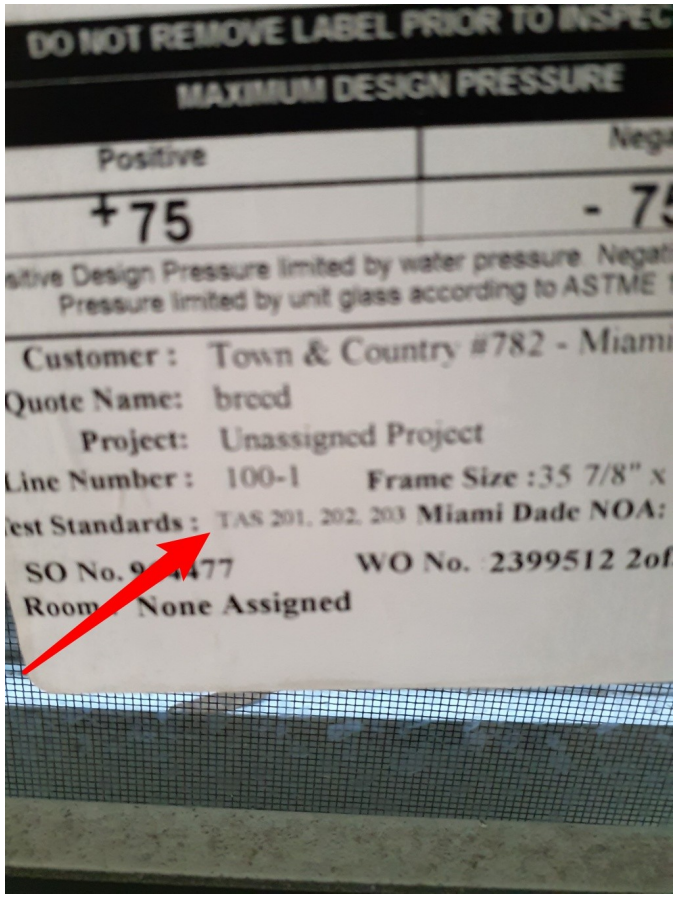
TAS 201 202 203

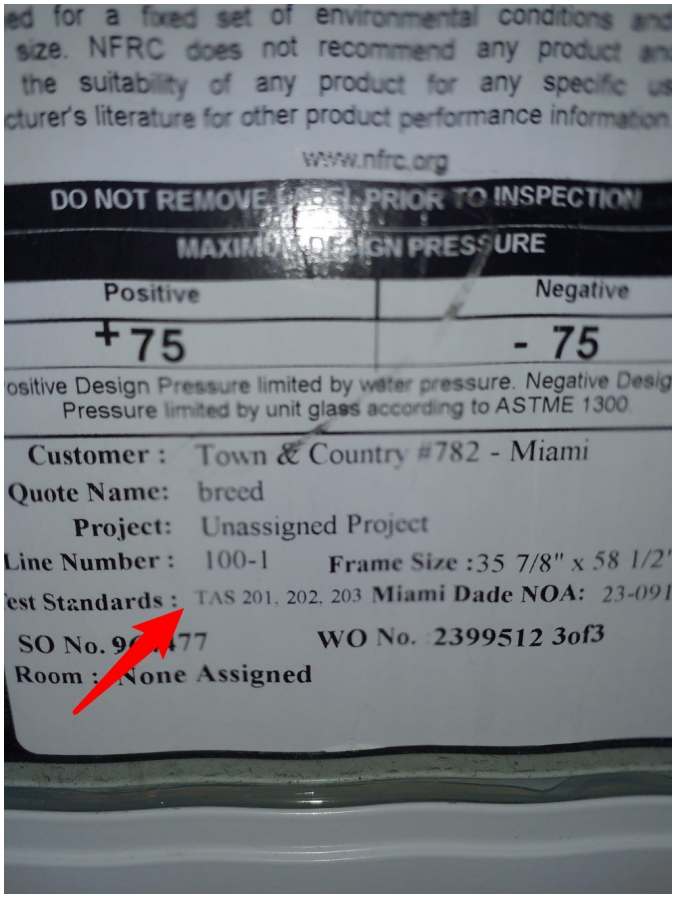
TAS 201 202 203
