Wind Mitigation Report

LOCATED AT:
204-1 - 204-11 Southard st
Key West, Florida 33040

PREPARED EXCLUSIVELY FOR:
Shipyard Condominium Building # 4

INSPECTED ON:
Thursday, August 14, 2025

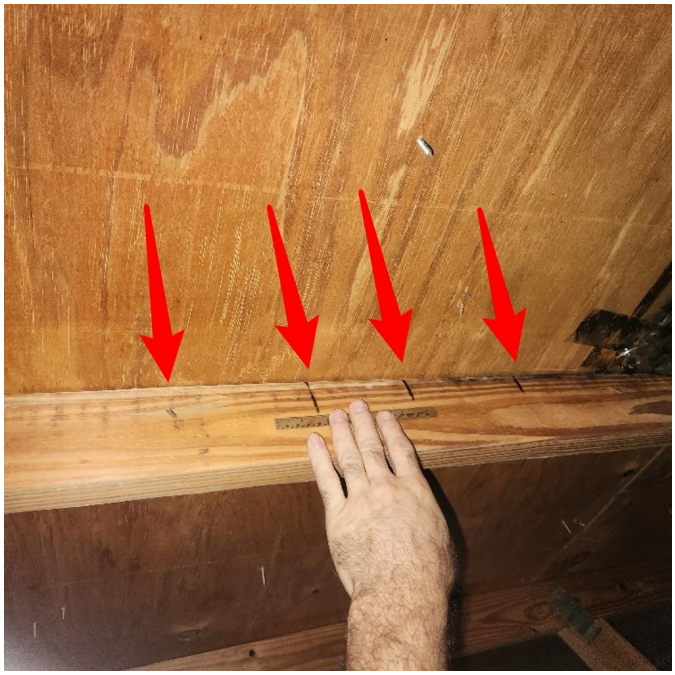
ROOF DECK

5/8 plywood nailed with 8D nails every 6 inches

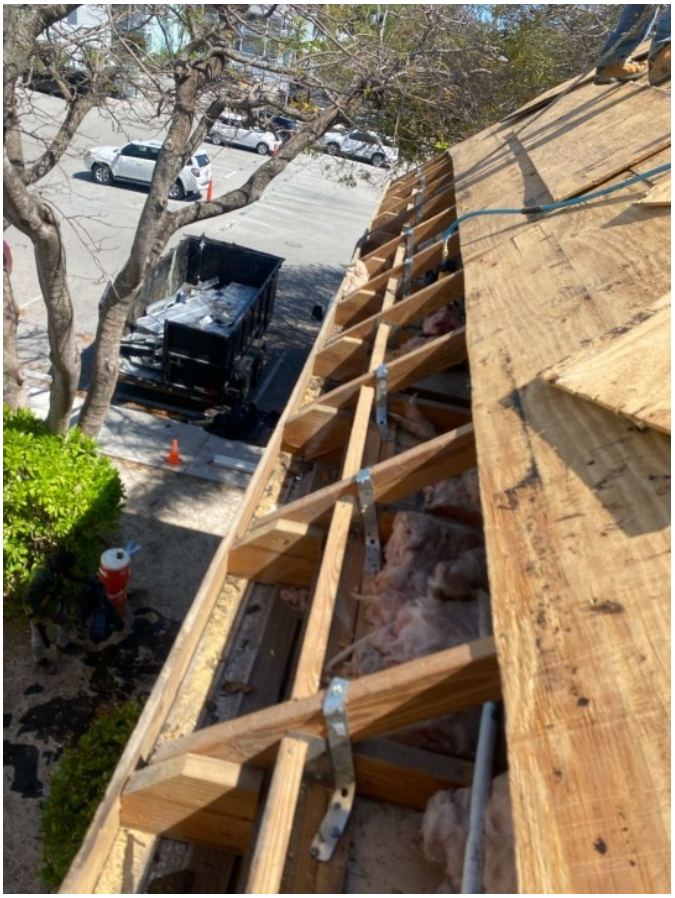
ROOF TO WALL

Double wraps with 4+ nails on either side .

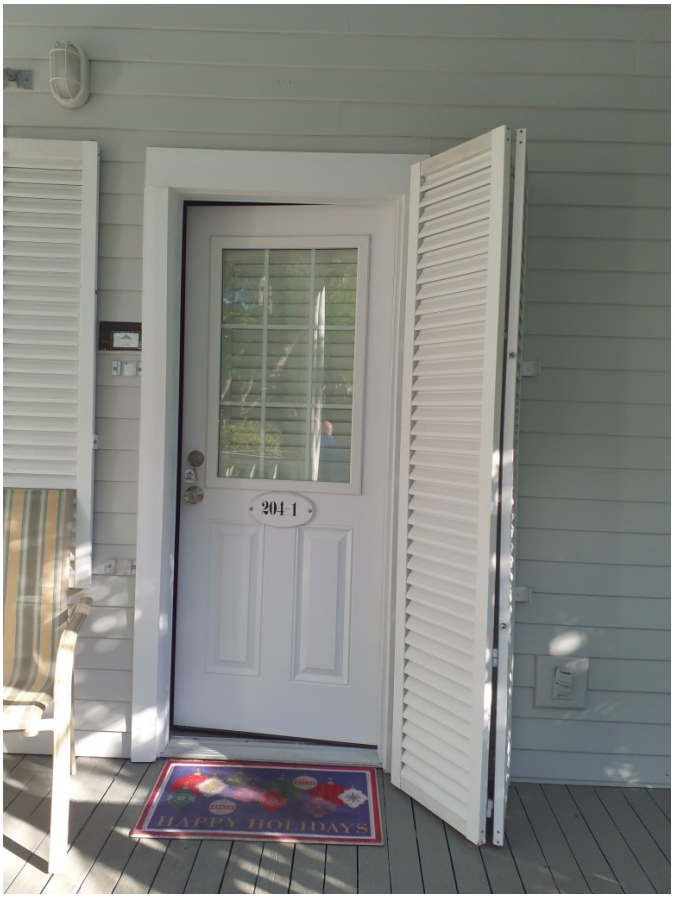
TAS 201 202 203

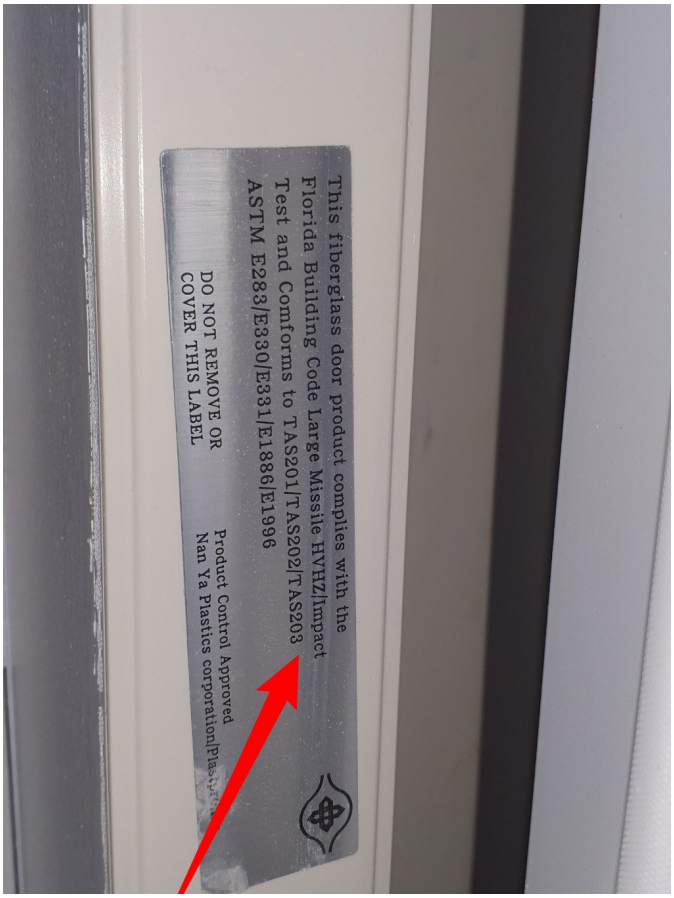
TAS 201 202 203
