Wind Mitigation Report

LOCATED AT:
208-1 -208-10 Southard st
Key West, Florida 33040

PREPARED EXCLUSIVELY FOR:
Shipyard Condominium Building #1

INSPECTED ON:
Tuesday, July 08, 2025

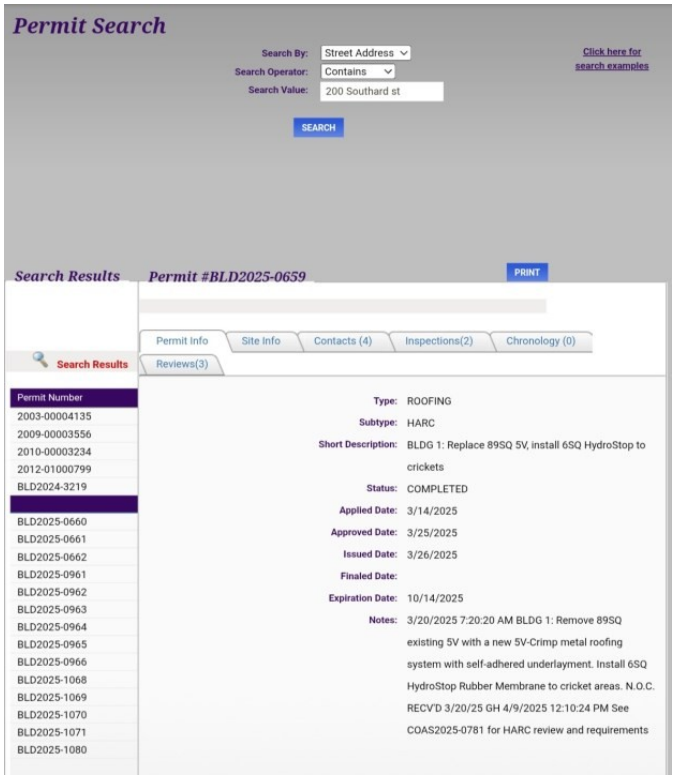
ROOF COVERING

Roof permit

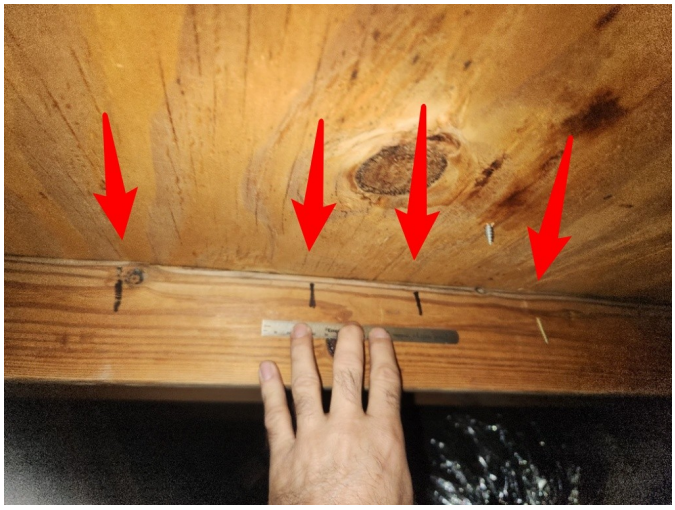
ROOF DECK

5/8 plywood nailed with 8D nails every 6 inches

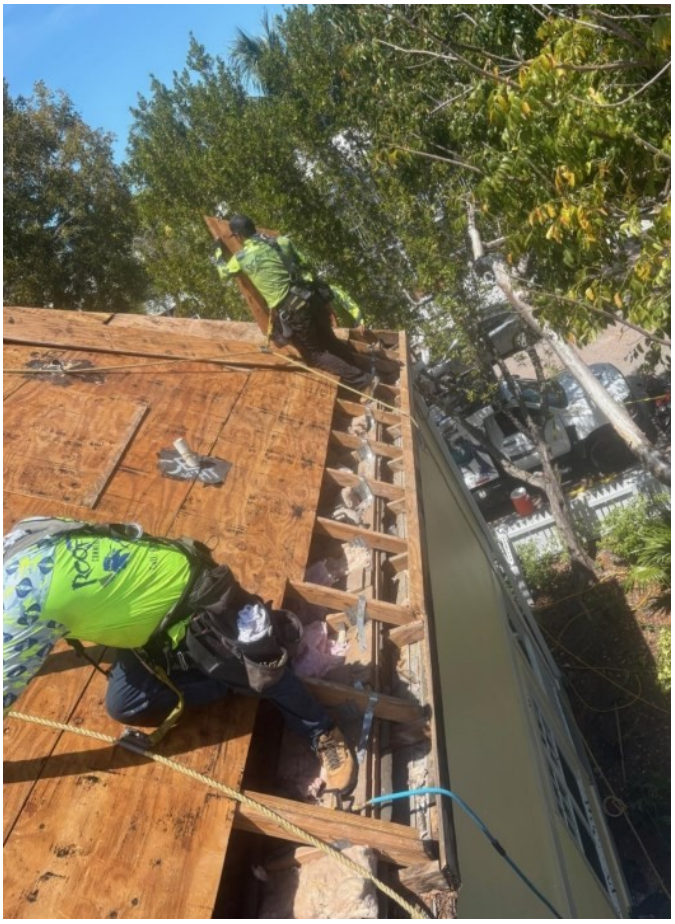
ROOF TO WALL

Double wraps with a single strap nailed to the top plate on both sides .

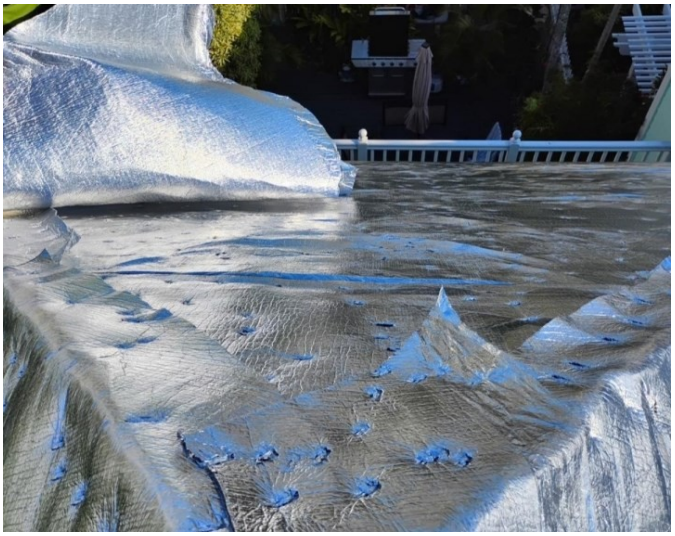
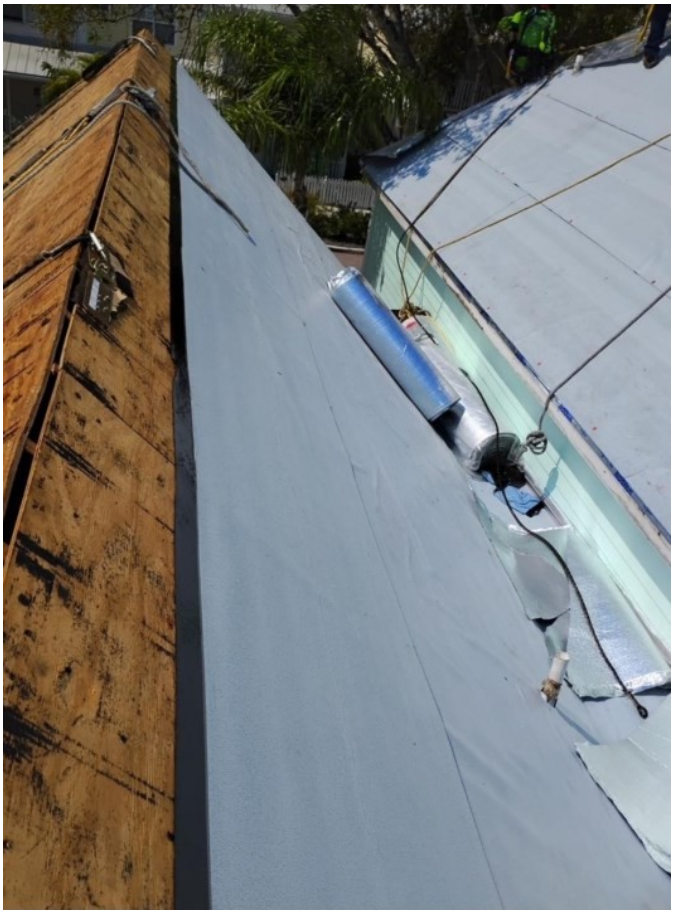
SWR installed

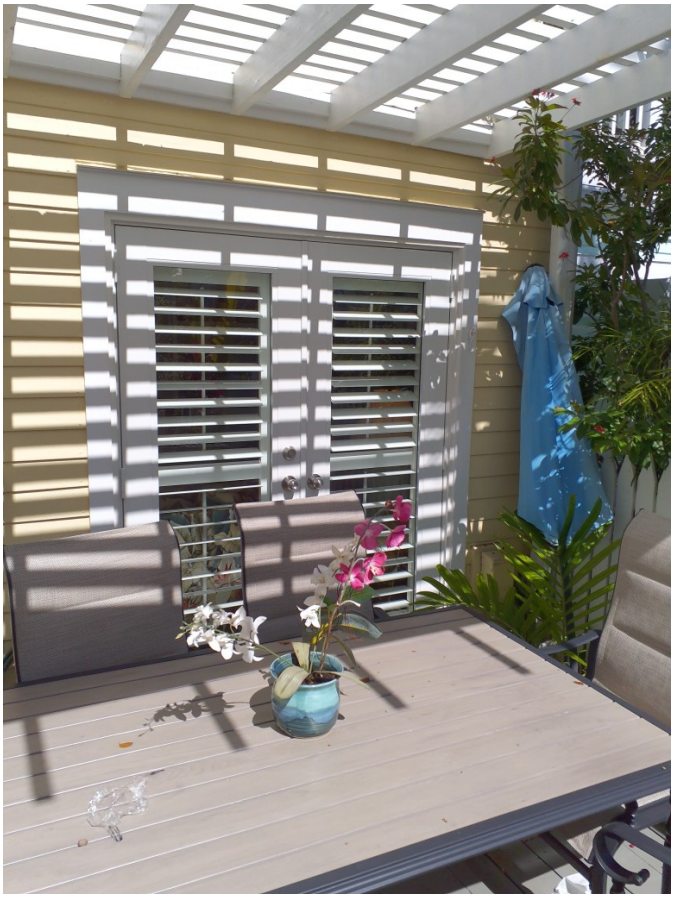
OPENING PROTECTION

All of the doors are hurricane impact rated

TAS 201 202 203

Miami Dade county approved

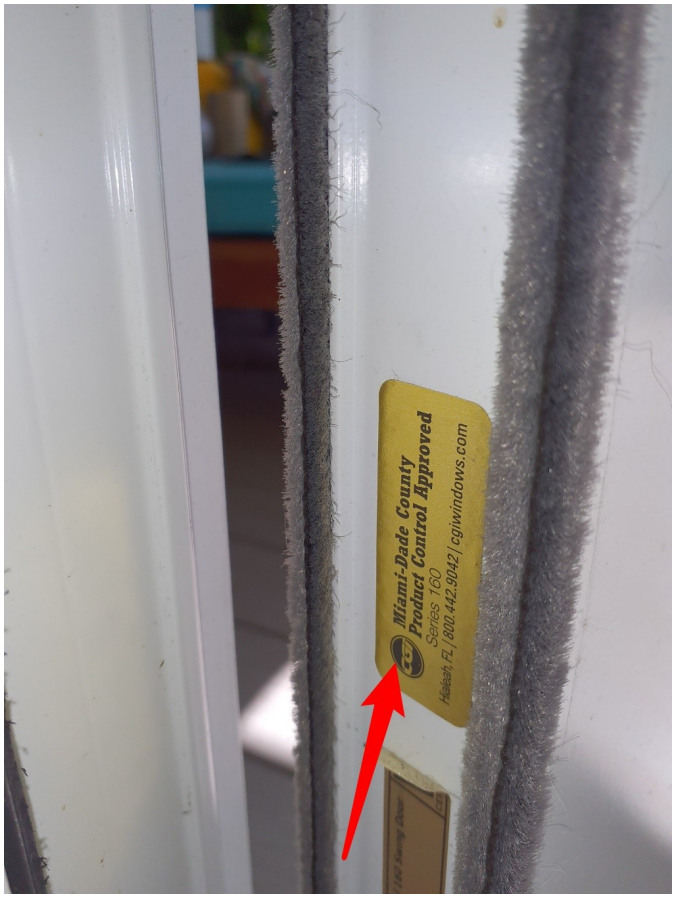
Miami Dade county approved

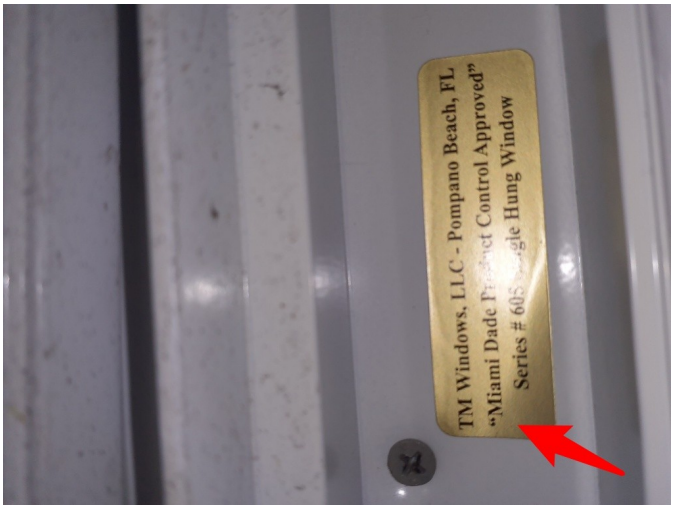
All of the windows are hurricane impact rated

Miami Dade county approved

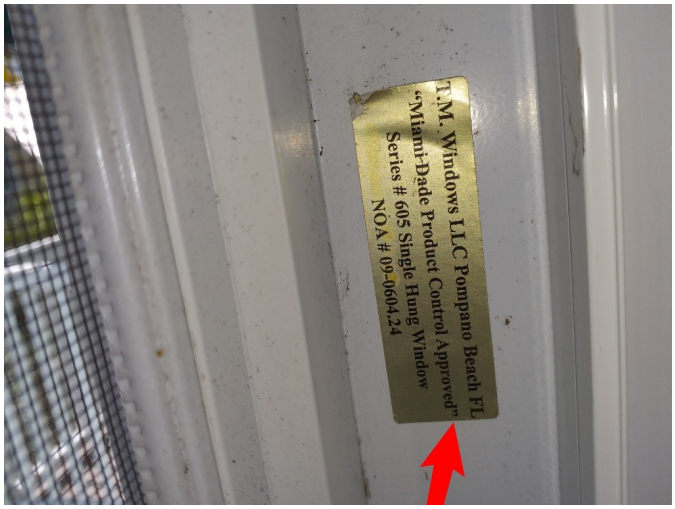
Miami-Dade county approved
