Wind Mitigation Report

LOCATED AT:
620 Thomas st units 156-158 & 256-258
Key West, Florida 33040

PREPARED EXCLUSIVELY FOR:
Shipyard Condominium Building # 8

INSPECTED ON:
Friday, October 03, 2025

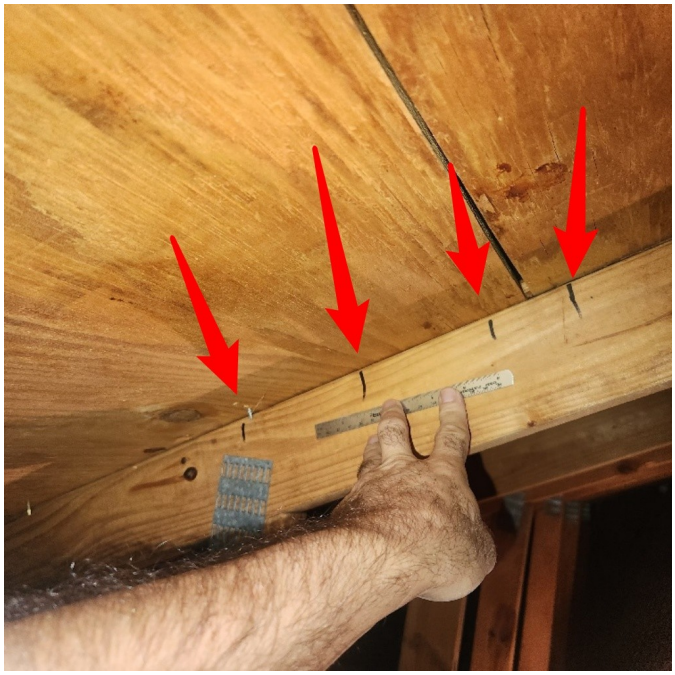
ROOF DECK

5/8 plywood nailed with 8D nails every 6 inches
