Wind Mitigation Report

LOCATED AT:
620 Thomas st units 159-162 & 260-262
Key West, Florida 33040

PREPARED EXCLUSIVELY FOR:
Shipyard Condominium Building # 9

INSPECTED ON:
Friday, October 03, 2025

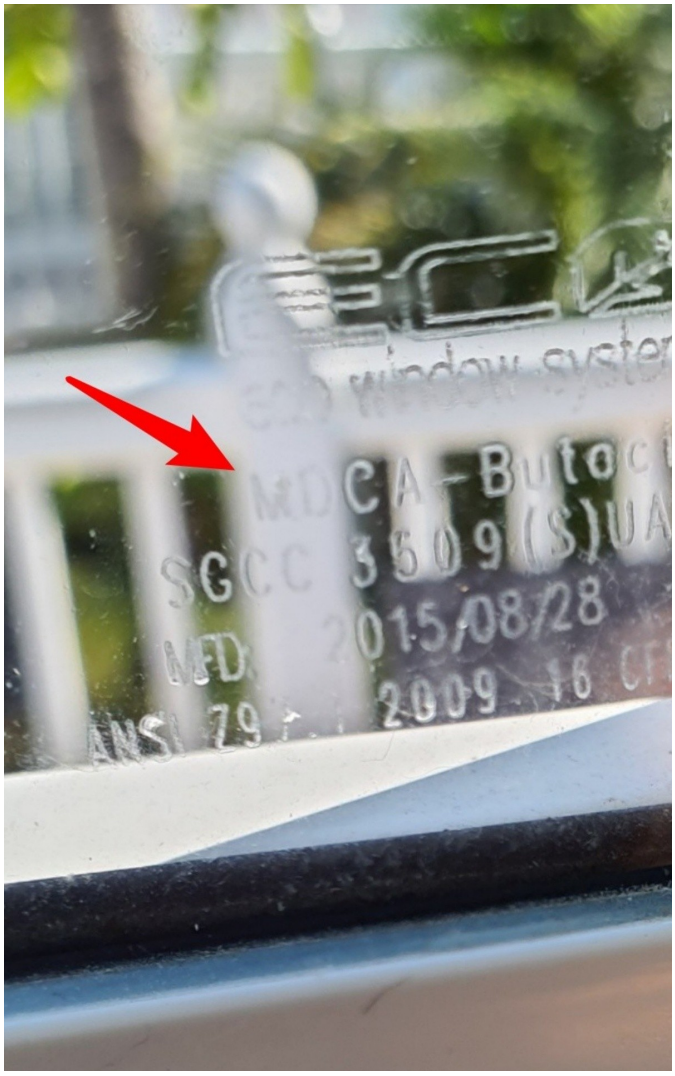
Miami-Dade county approved
