Wind Mitigation Report

LOCATED AT:
620 Thomas st Building #17
Key West, Florida 33040

PREPARED EXCLUSIVELY FOR:
Shipyard Condominium Units 178-182 & 278-282

INSPECTED ON:
Friday, June 06, 2025

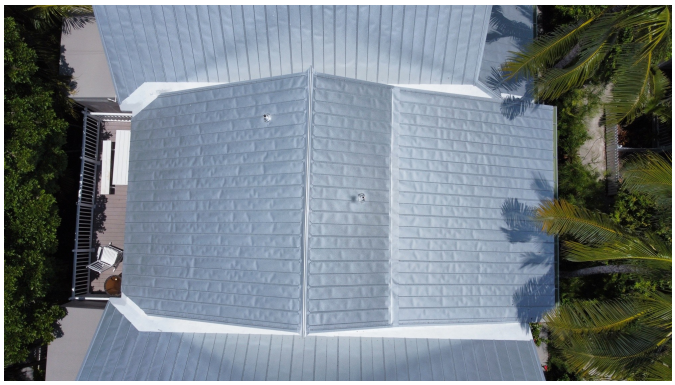
Metal roof photos

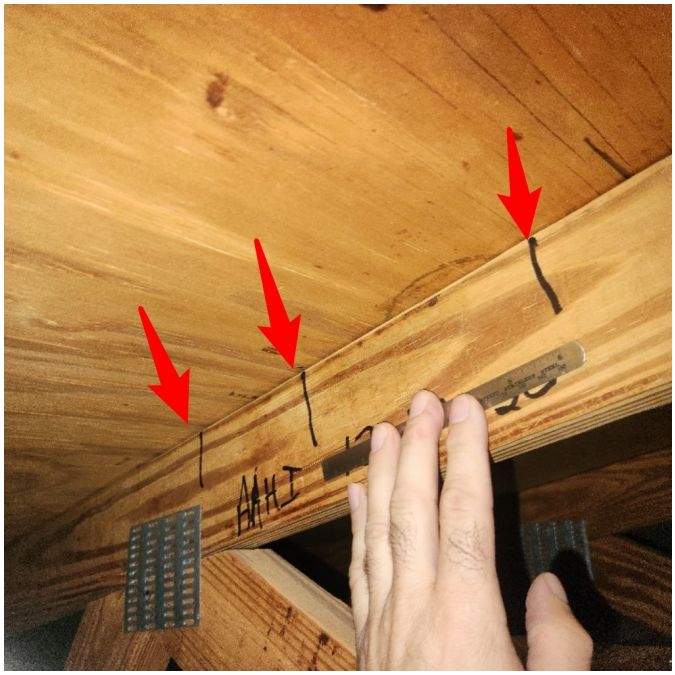
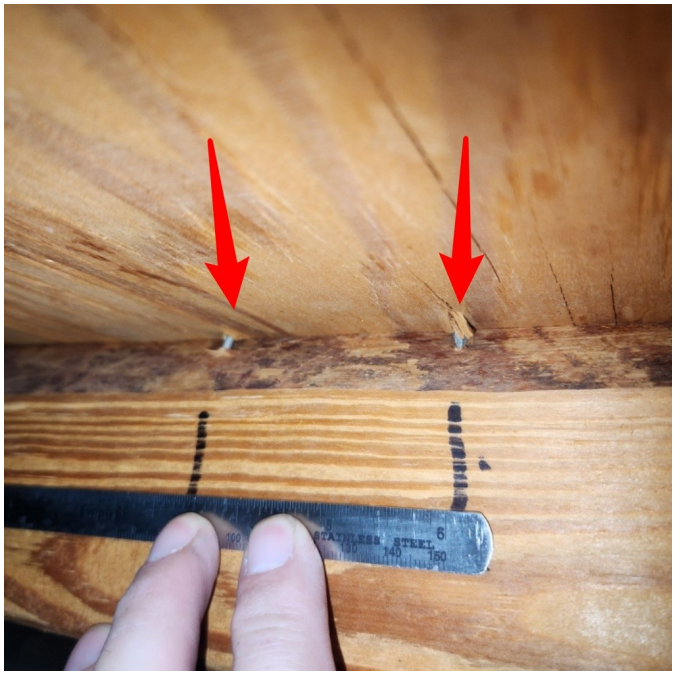
ROOF DECK

5/8 plywood nailed with 8D nails every 6 inches

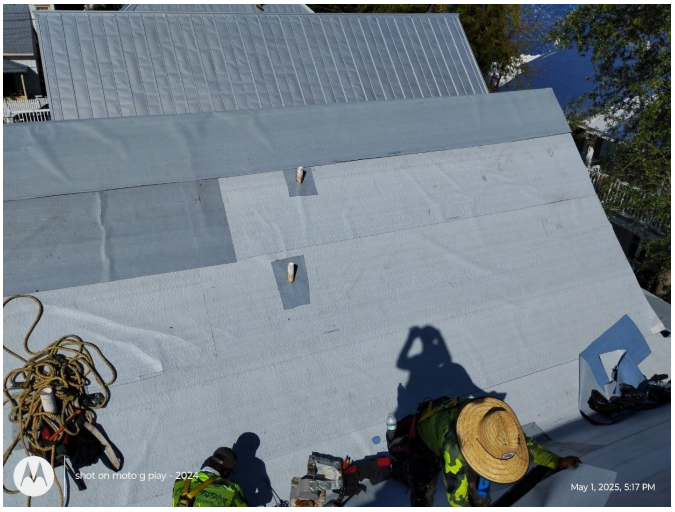
SWR installed

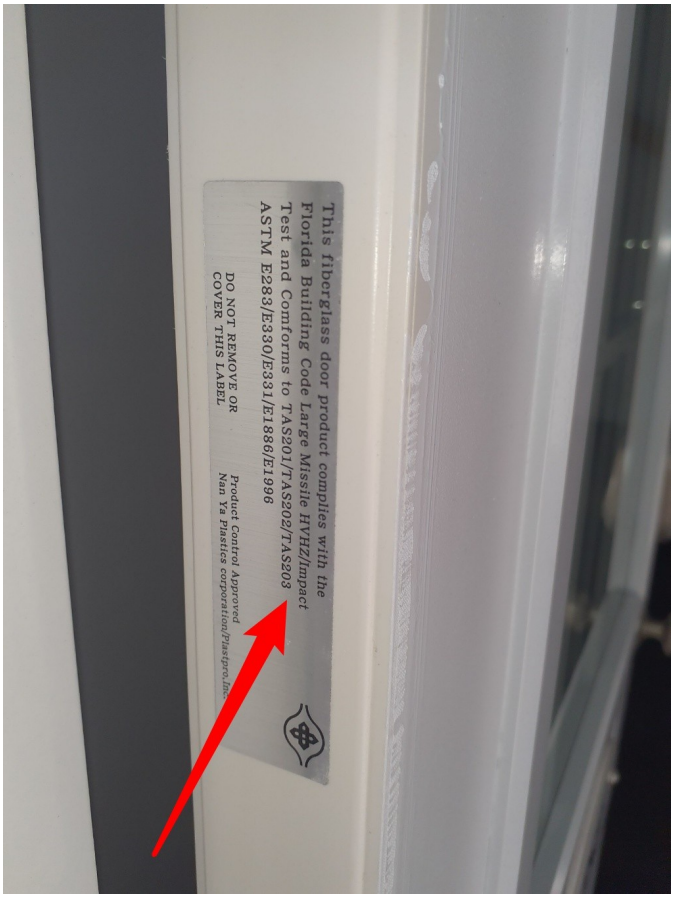
Miami-Dade county approved

TAS 201 202 203

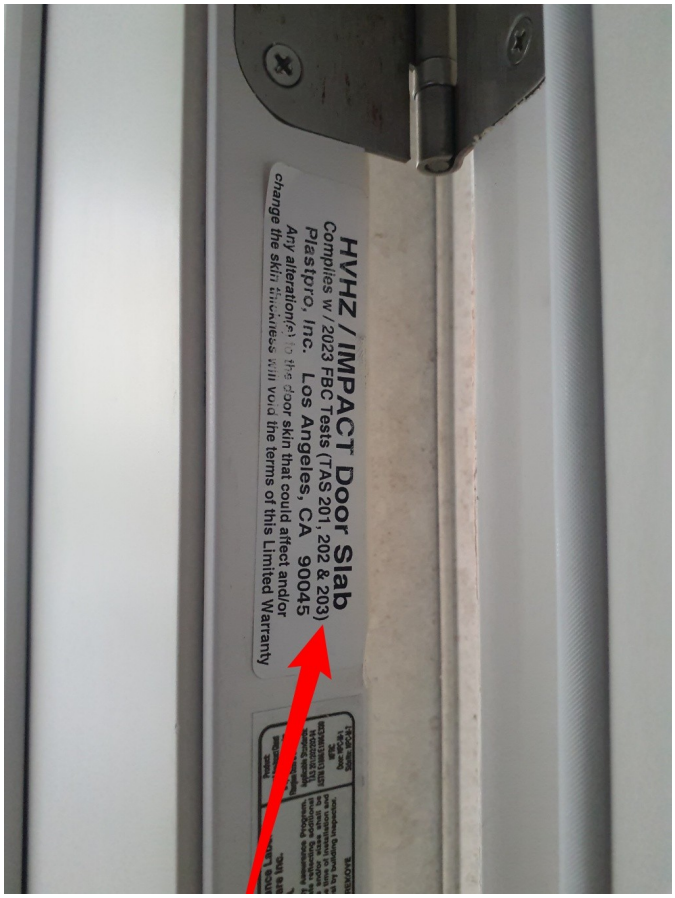
TAS 201 202 203

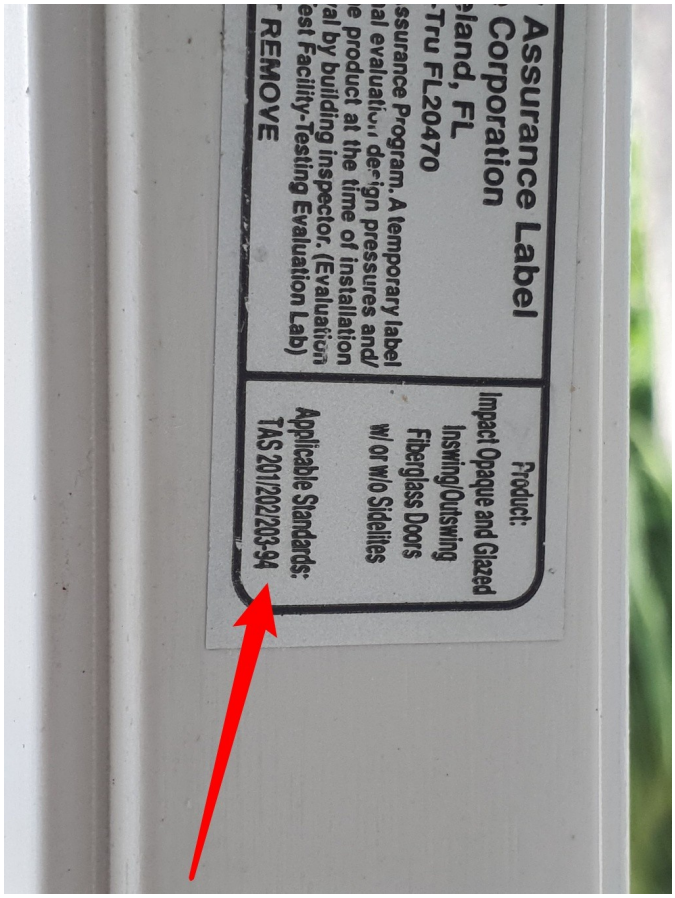
TAS 201 202 203
