Wind Mitigation Report

LOCATED AT:
620 Thomas St units 183-187 & 283-287
Key West, Florida 33040

PREPARED EXCLUSIVELY FOR:
Shipyard Condominium Building # 14

INSPECTED ON:
Tuesday, July 22, 2025

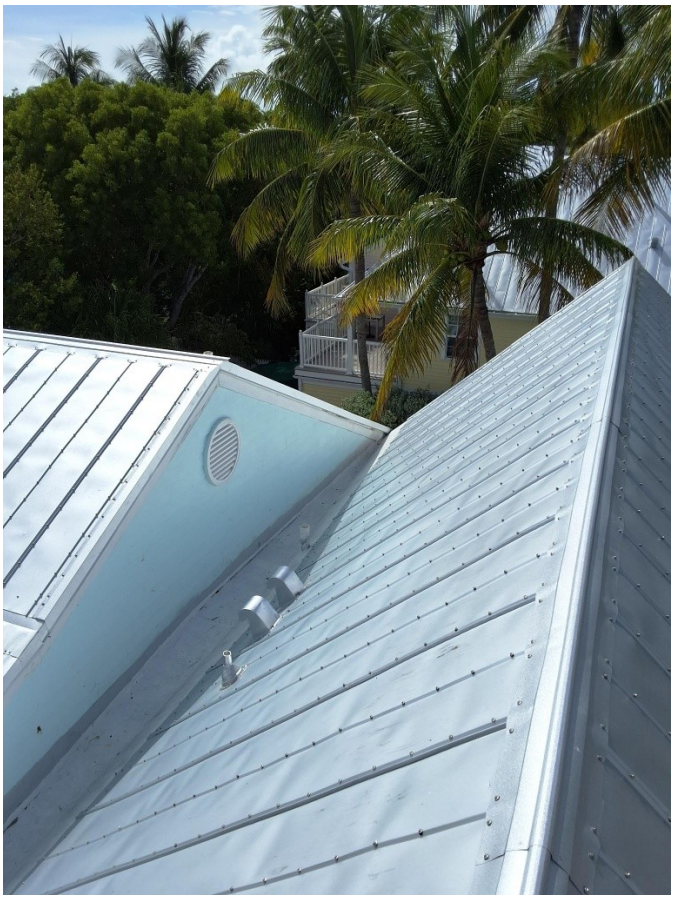
Metal roof photos

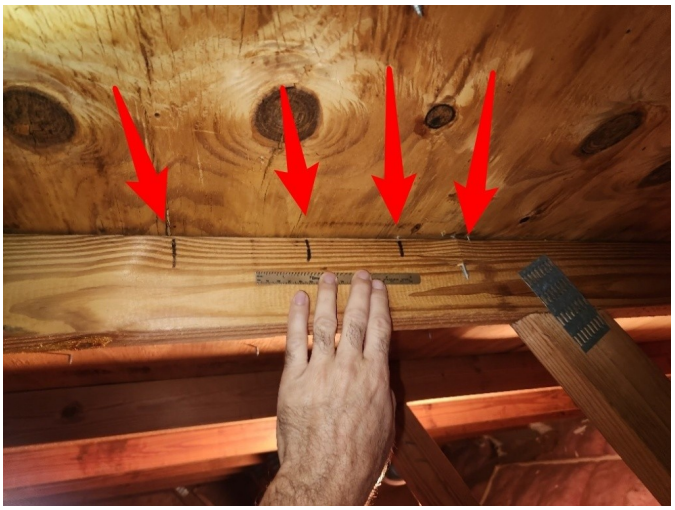
5/8 plywood nailed with 8D nails every 6 inches

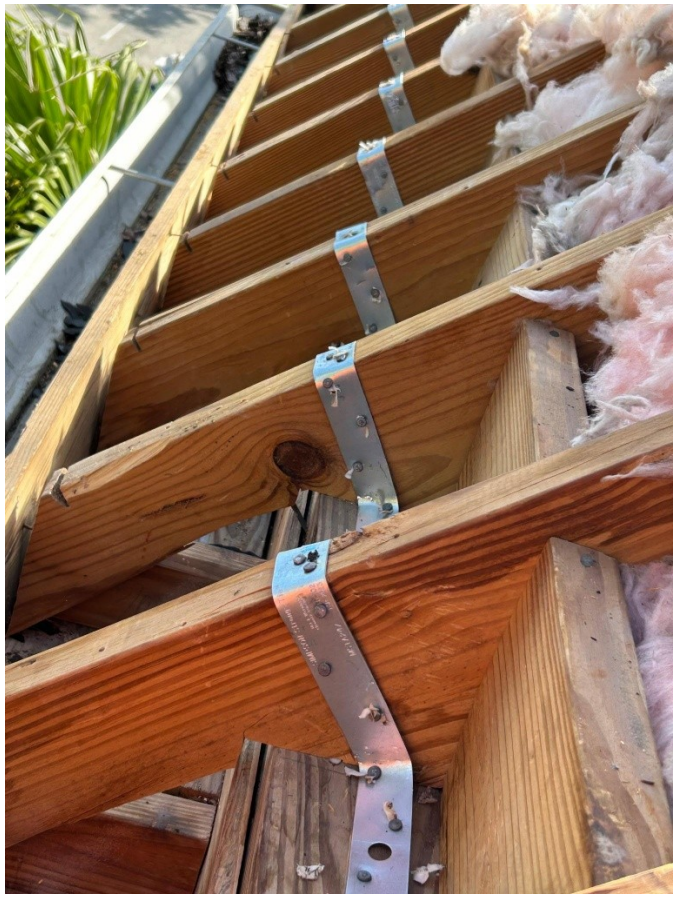
Double wraps with 4+ nails on either side .

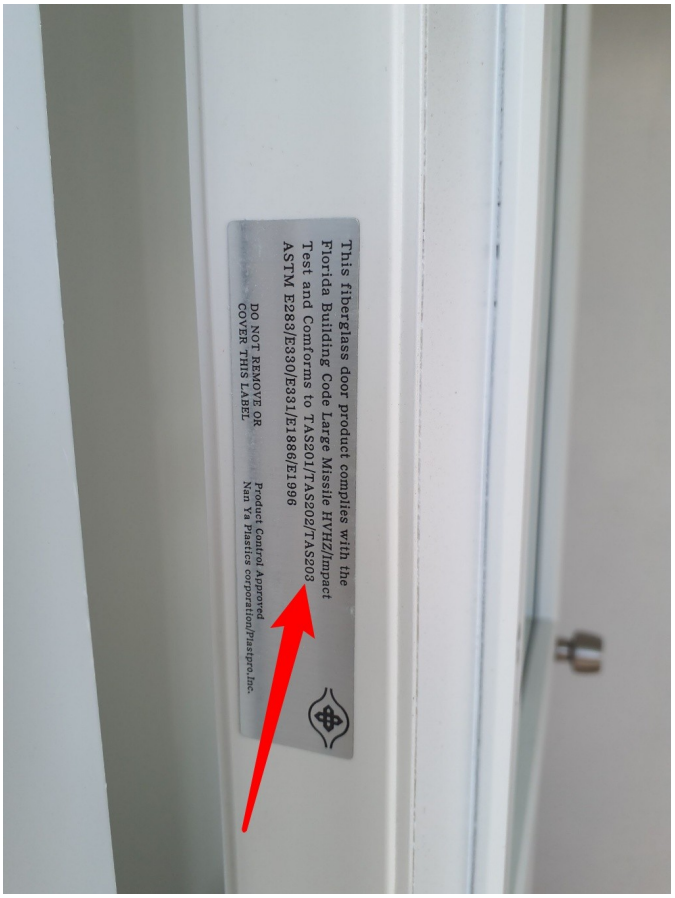
TAS 201 202 203

Miami-Dade county approved
