Wind Mitigation Report

LOCATED AT:
620 Thomas st units 196-199 & 296-299
Key West, Florida 33040

PREPARED EXCLUSIVELY FOR:
Shipyard Condominium Building # 18

INSPECTED ON:
Tuesday, July 8, 2025

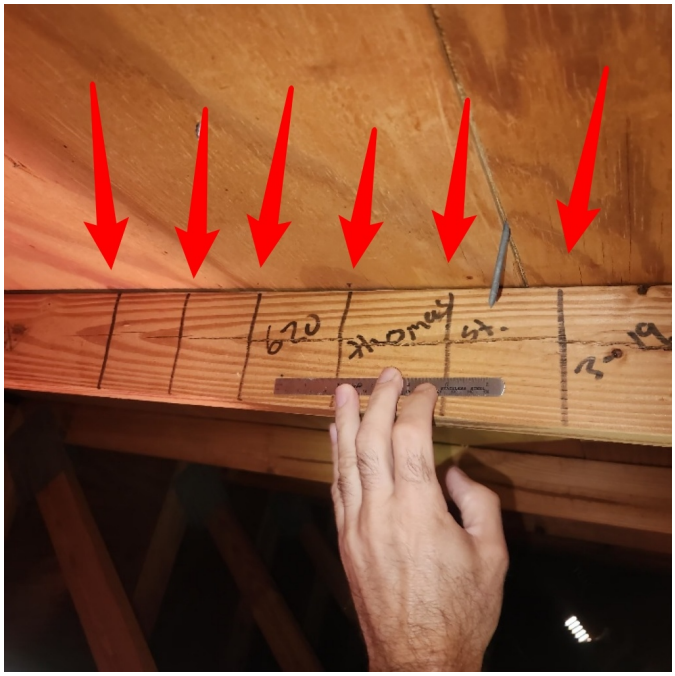
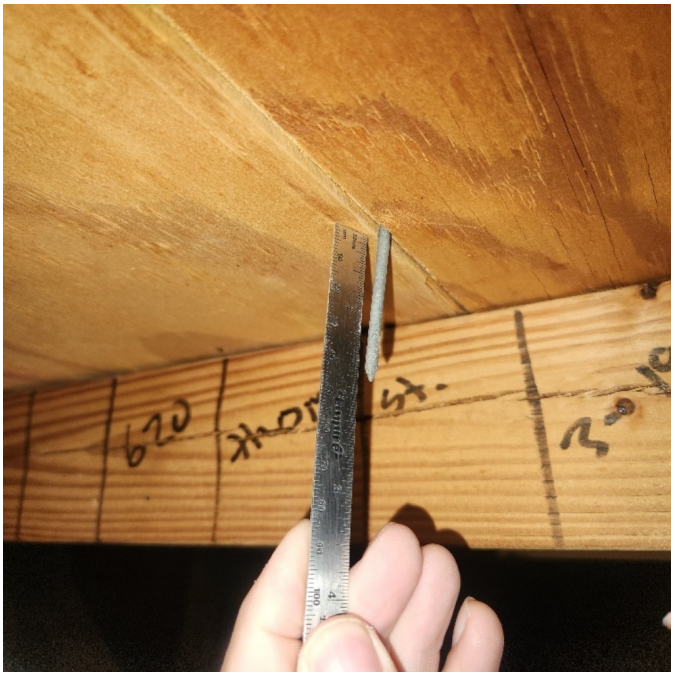
ROOF DECK

5/8 plywood nailed with 8D nails every 6 inches

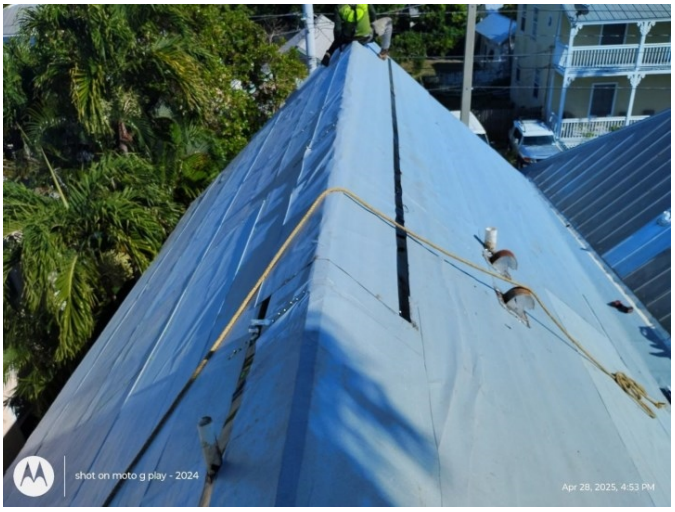
SWR installed

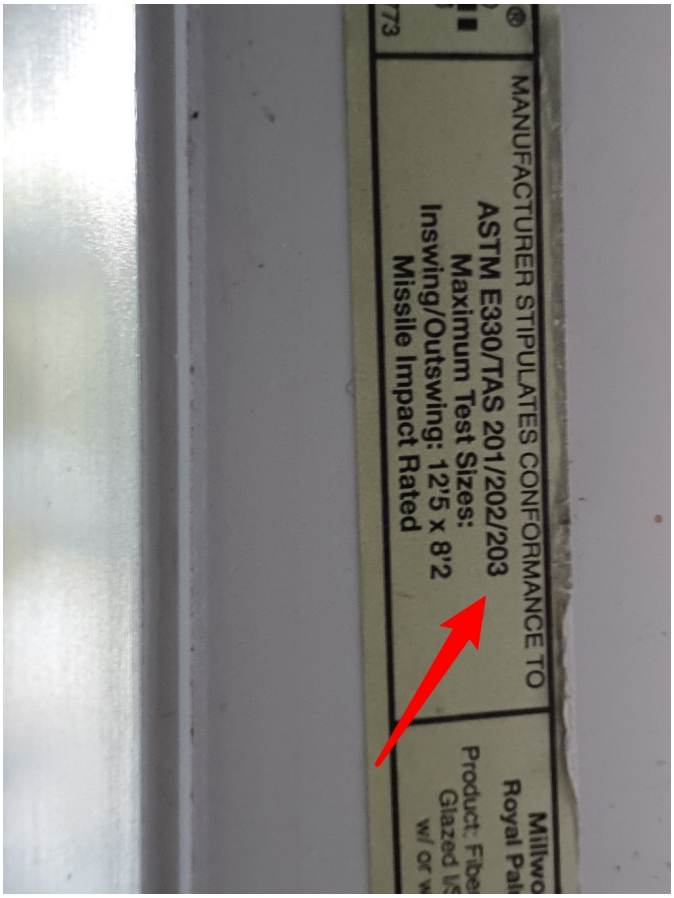
All of the doors are hurricane impact rated

TAS 201 202 203

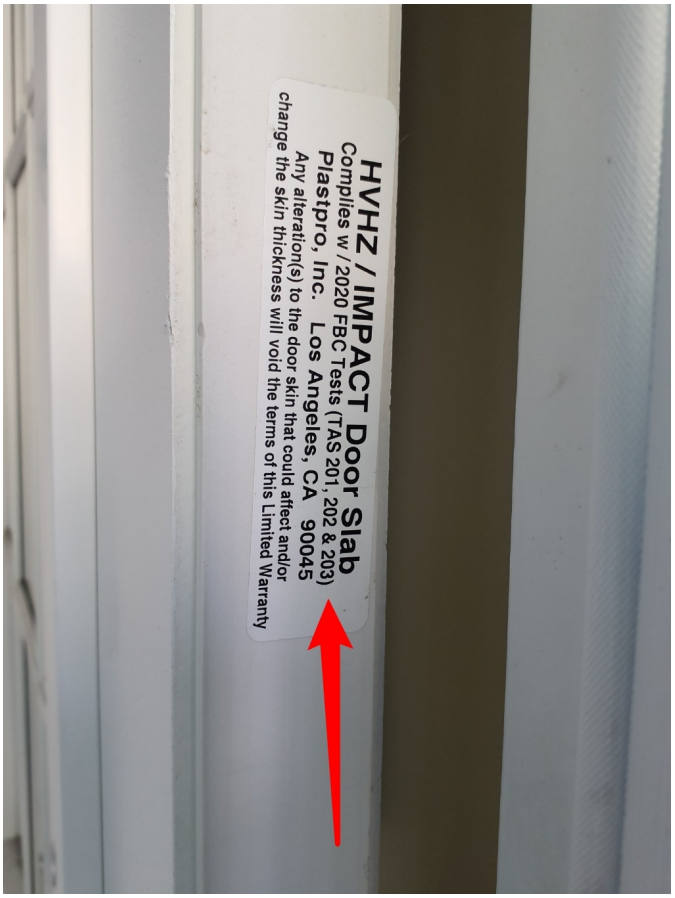
TAS 201 202 203
